INDIAN MOUNTAIN LAKE DAM

NDI ID NO. PA-00783  
DER ID NO. 45-227

PHASE I INSPECTION REPORT  
NATIONAL DAM INSPECTION PROGRAM

JANUARY 1980

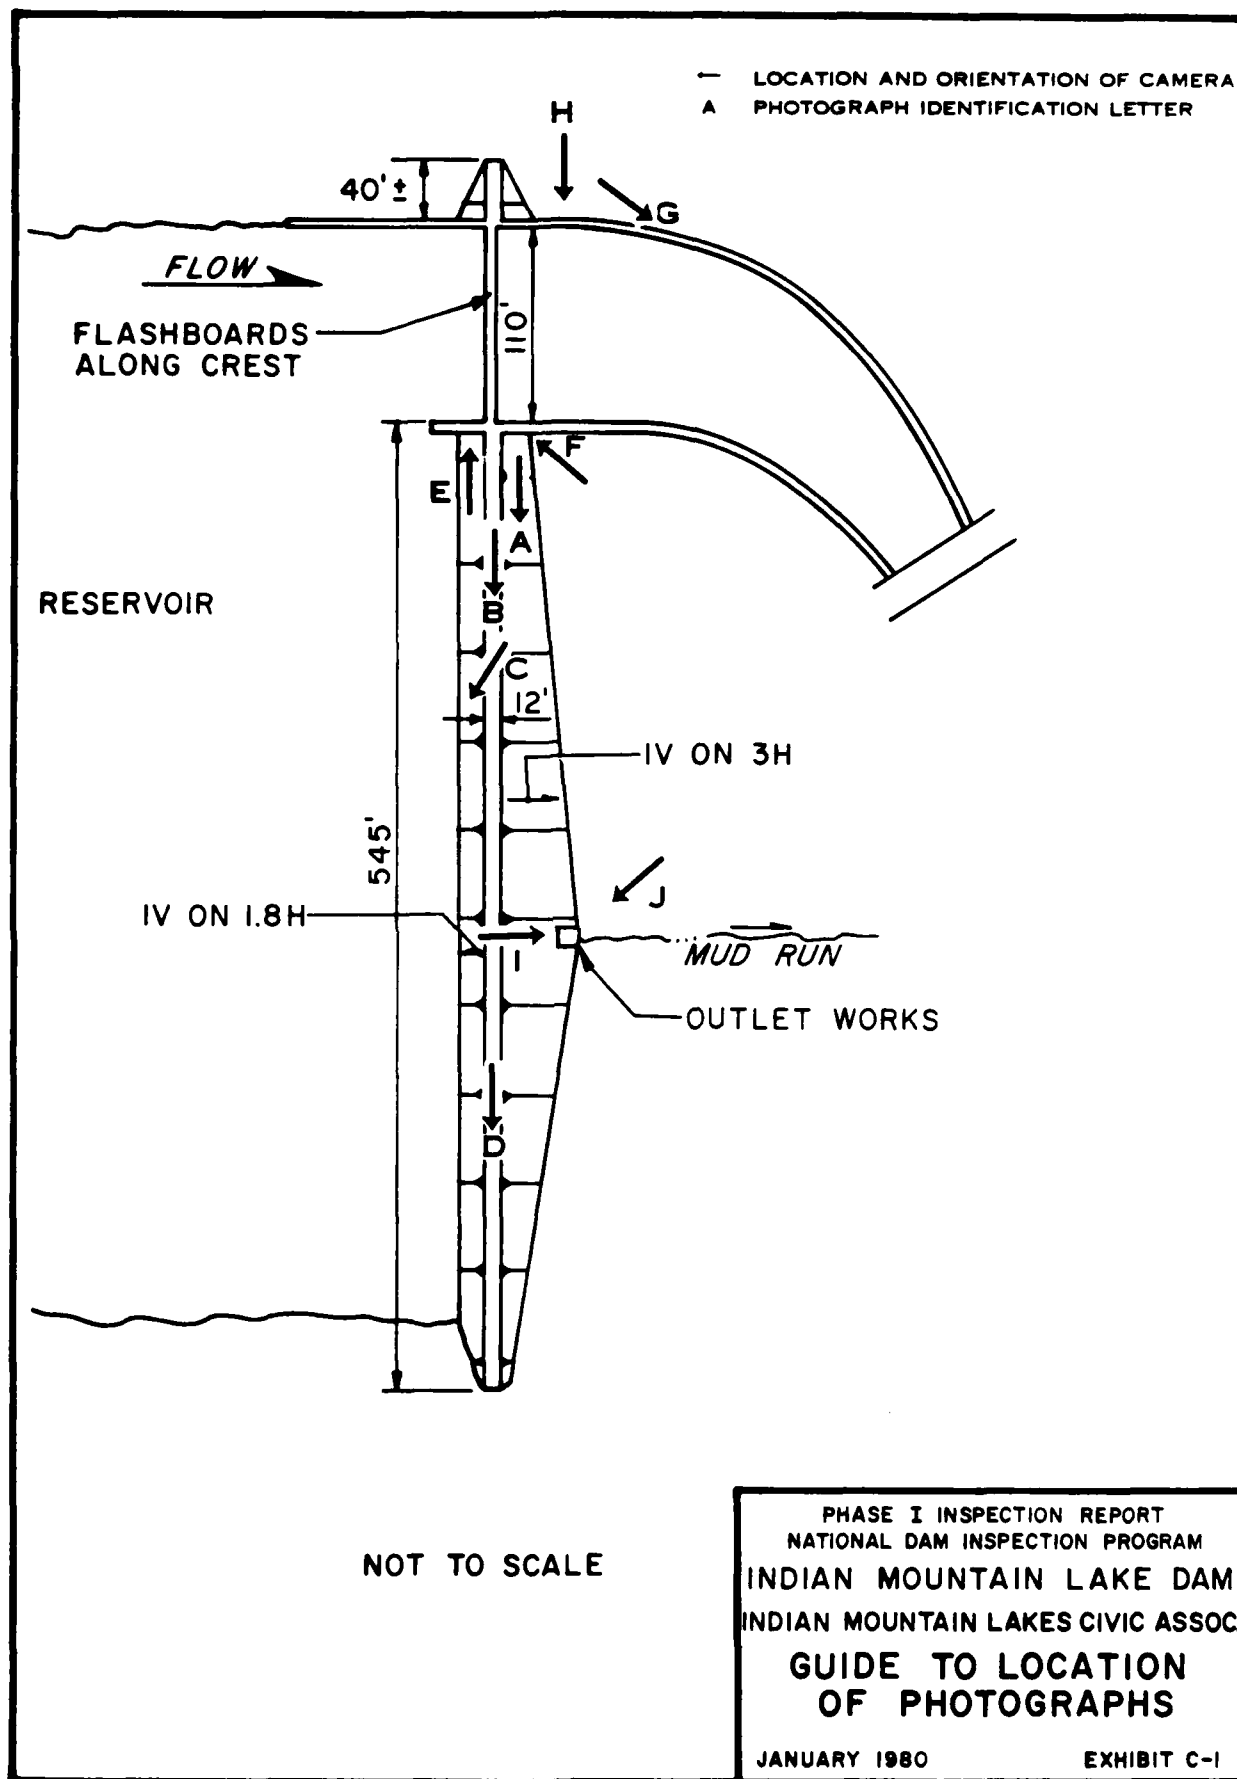
J. Outlet Works Headwall

The outlet works is in poor condition. Although available drawings indicate that the outlet works has a gate, no evidence of the gate operating mechanism was observed. The Owner's maintenance supervisor believed it was submerged, but said that he had never seen it. No deficiencies were observed at the steel conduit. The outlet works structure has failed structurally. The left sidewall has been removed and is lying about 30 feet downstream on the overbank of Mud Run. The right sidewall is tilted and separated from the headwall (Photographs I and J). There are structural cracks in the headwall (Photograph J).
